## Replacing the 1961 to 1963 Shift Detent and Shift Lever

Tom Gugliotta VTCI Member #9624

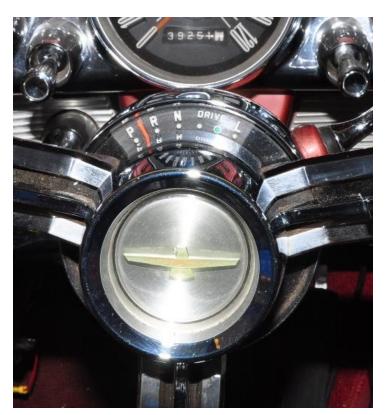
of my problem. The Squarebird article also doesn't mention any snafus that you might run into, of which I ran into several. Below you can see my shifter is ready to jump into reverse and the car won't start unless I press up on the shifter.

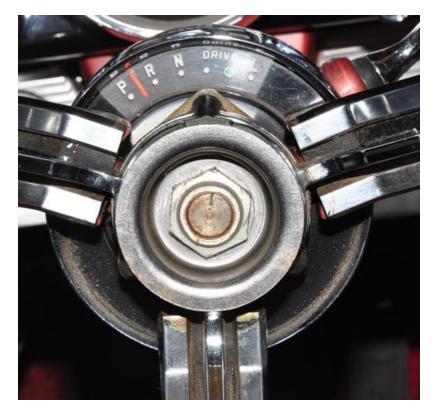
Pull off the trim cap and remove the nut with a 15/16" socket and 6" extension.

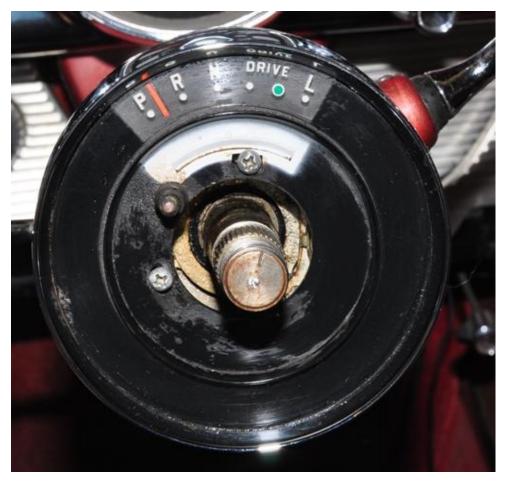
The bolts to use for the puller are 5/16"-24. It comes off with minimal effort.

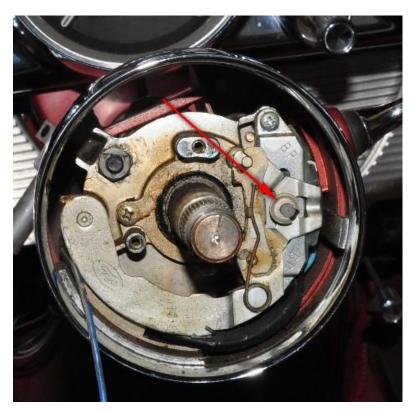
The canceller is retained by a horseshoe nut and spring on a small nylon shaft. Slide the nut off very carefully, keeping a finger on the post to prevent the spring from flying into oblivion. This will be the most confounding part of the whole procedure. Reassembly was next to impossible for me, however after losing and refinding the parts multiple times, I finally got it back together.

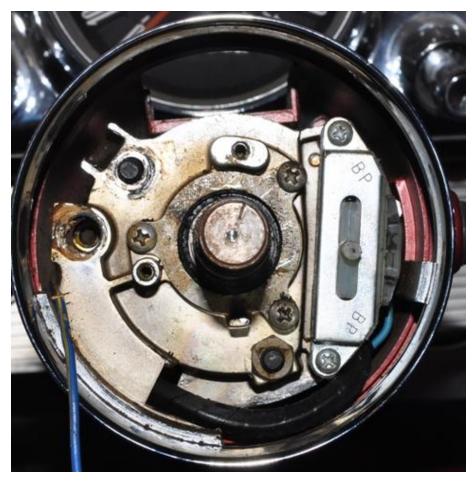
Pull the canceller lever out. Now the nut at 5 o'clock is visible. Don't remove it yet though, and actually, leave

the one at 10 o'clock in for now because there was another surprise.

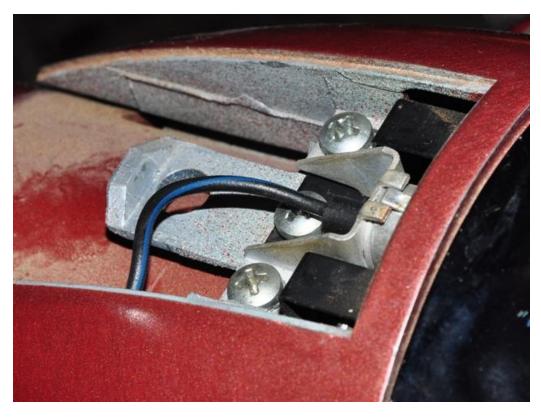
Remove the cover panel with a tape covered screwdriver. Remove the three screws holding the shift indicator

light and black background piece in place. Pull the black background piece out from the front and set the light aside.

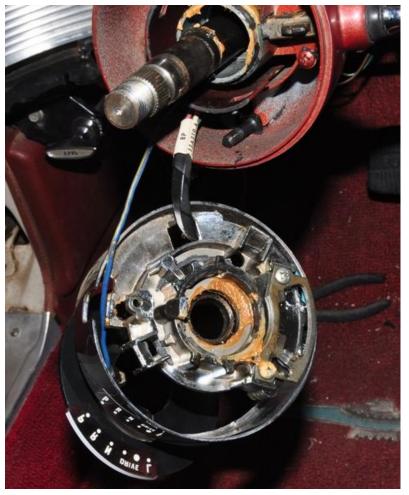
Finally, the detent plate and shift lever are in sight. Notice one of the black retaining bolts in the steering column. This was addressed in the Squarebird article, but I'll discuss it again as it proves tricky during

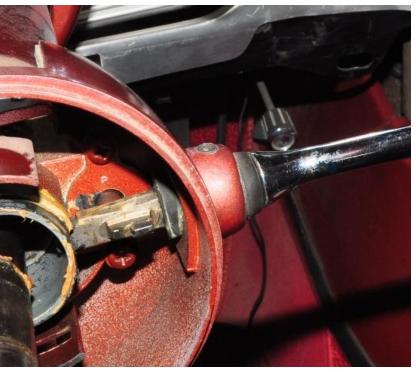
The spring and nut was frustrating enough, now this pin retaining the shift lever has to come out without destroying anything. I moved the shifter to low and drove it out with a large nailset. It took a lot of force to get

it going, but once it started moving it slid out without too much force. Nevertheless, it was nerve racking to remove.

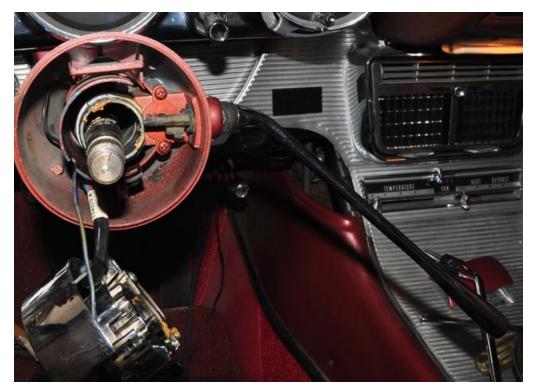
To remove the shifter, rotate it 90 degrees down to free it from the rear pressure pin. It then pulls out easily. Just reverse the process when installing the new shifter. If the rubber binds up during installation, smear a small dab

of petroleum jelly on it and it will slide in easily. Driving the pin back in is also a challenge, but it goes in with some powerful but careful hammering with a center punch or large nailset.

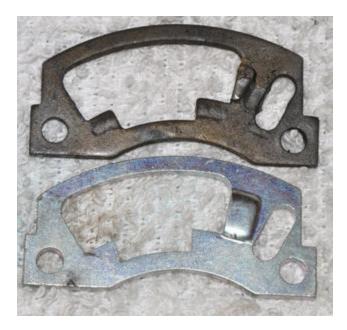
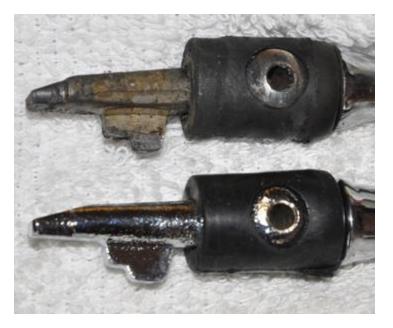
Here is a comparison of the old and new parts. The reproductions both look improved in design.

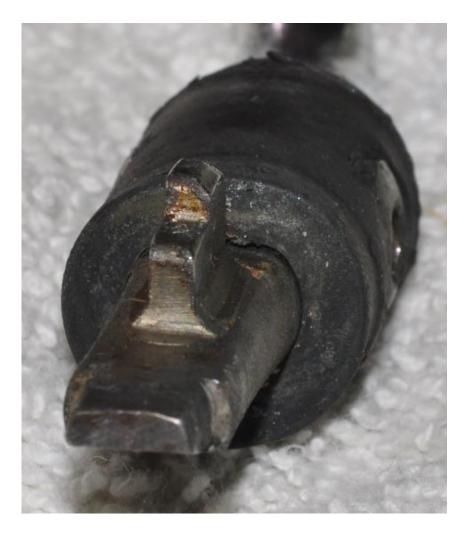
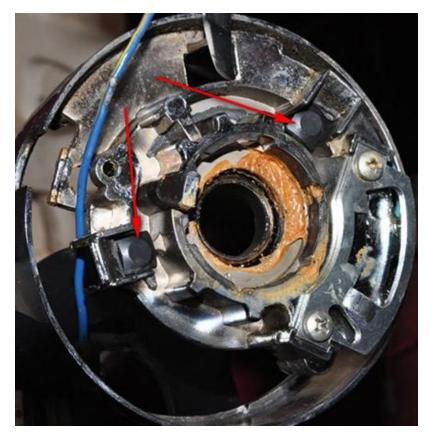
Here is my problem. The edge has chamfered on the shift lever. This thing was a time-bomb, ready to fall into reverse.
